# TROUBLESHOOT CHECK LIST

02-15-96

REPAIR NO. 4 FEB 09, 1996

SYCAMORE SYSTEMS INC  
division of  
LYON METAL PRODUCTS  
REPAIR NO. 6 FEB 08, 1996

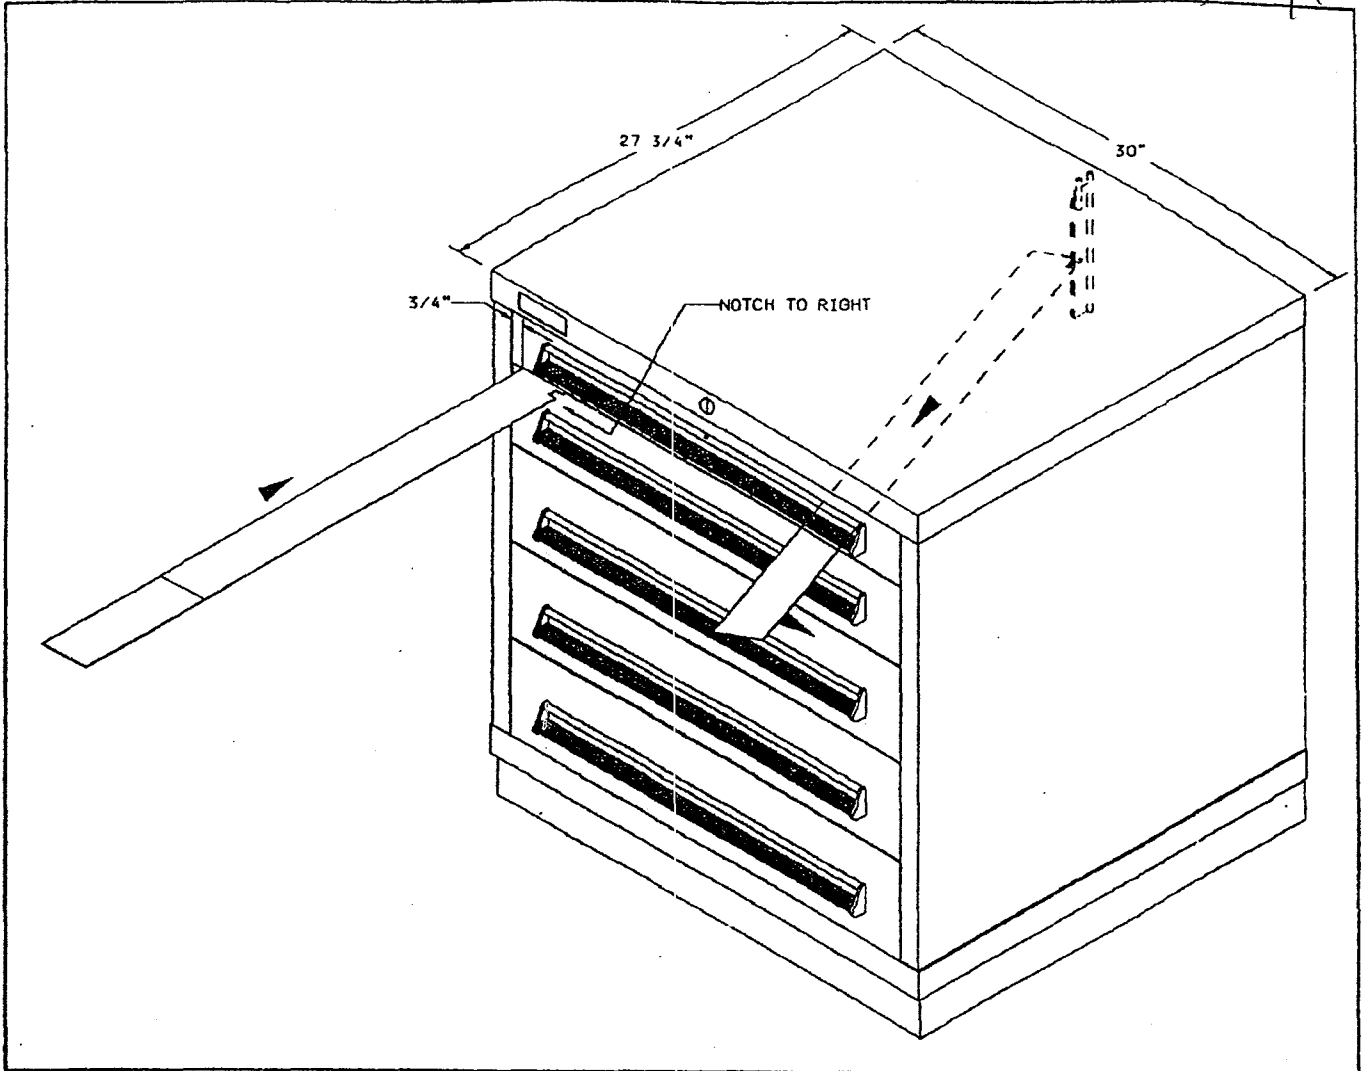
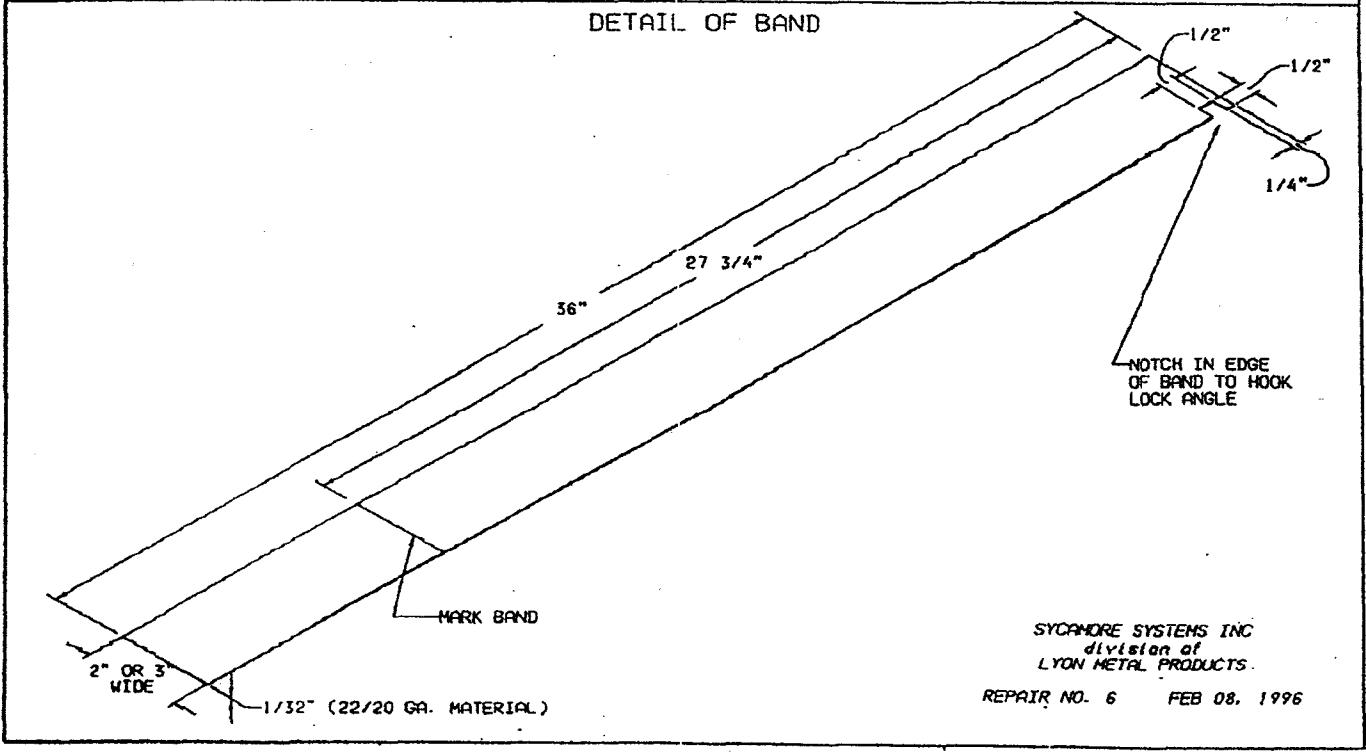
DETAIL OF BAND

- 1) FABRICATE A STEEL BAND AND MARK PER DIMENSIONS SHOWN ON DRAWING "REPAIR NO. 6".
- 2) INSERT THE BAND AT THE LEFT HAND SIDE OF THE DRAWER. WITH THE NOTCH ON THE RIGHT. BETWEEN TWO ADJACENT SHORT HEIGHT DRAWER FRONTS AS SHOWN. (THIS WILL ALLOW THE BAND TO BE SUPPORTED BY THE DRAWER BODY BELOW WHEN PUSHING THE BAND TOWARD THE REAR OF THE CABINET).

- 3) SLIDE THE BAND STRAIGHT INTO THE CABINET LETTING IT REST ON THE SIDE OF THE DRAWER BODY UNTIL IT HITS THE BACK OF THE CABINET. (THE DRAWER FRONT SHOULD BE CLOSE TO THE 27 3/4" MARK MADE ON THE BAND).

- 4) MOVE THE BAND TO THE RIGHT TOWARDS THE CENTER OF THE CABINET, KEEPING THE BAND AGAINST THE CABINET BACK UNTIL IT STOPS AGAINST THE CABINET BACK CENTER SEAM. WHEN THE BAND HITS THE SEAM, PULL IT FORWARD SLIGHTLY (1/2" to 3/4") TO CLEAR THE SEAM. THEN CONTINUE TO MOVE THE BAND TOWARDS THE RIGHT UNTIL YOU HIT THE LOCK ANGLE.

- 5) WITH THE BAND AGAINST THE LOCK ANGLE. MOVE THE FRONT END OF THE BAND TO THE RIGHT KEEPING THE OPPOSITE END AGAINST THE LOCK ANGLE. HOOK THE NOTCH IN THE BAND ONTO THE EDGE OF THE LOCK ANGLE. (THE BAND MAY HAVE TO BE MOVED BACK AND FORTH TO ENGAGE THE NOTCH).

- 6) IF THE KEY IS UNLOCKED AND THE BAND IS HOOKED INTO THE LOCK ANGLE. PULL THE BAND TO THE RIGHT AND FORWARD. THIS SHOULD FREE THE LOCK ANGLE. IF IT DOES NOT, THE LOCK ANGLE MAY BE JAMMED BY SOMETHING THAT HAS FALLEN OUT OF A DRAWER. FIND SOME ADDITIONAL HELP AND HAVE THAT PERSON TIP AND DROP THE CABINET WHILE YOU ARE PULLING ON THE BAND.

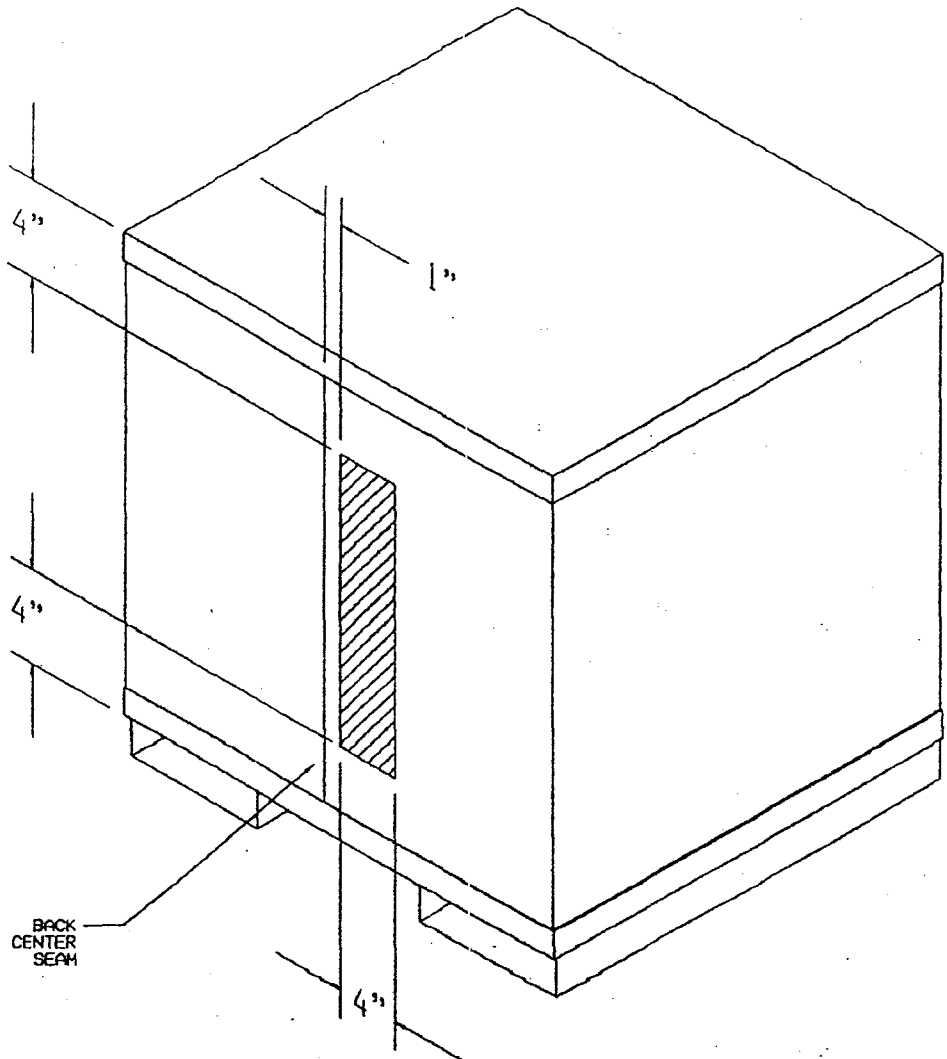
LES-04A

NOTE: THIS FEATURE CAN HOWEVER, BE BI-PASSED BY OPENING TWO OR MORE DRAWERS SIMULTANEOUSLY. IF THE OPENED DRAWERS ARE ALL NOT CLOSED SIMULTANEOUSLY, LOCK MECHANISM DAMAGE WILL OCCUR IF OPENED DRAWERS ARE FORCED CLOSED. 90% OF ALL LOCK MECHANISM PROBLEMS ARE CAUSED BY THIS CONDITION. THE RESULT IS A BENT LOCK ANGLE ASSEMBLY.

PROCEDURE TO RE-ASSEMBLE LOCK ANGLE ASSEMBLY INTO CABINET

BEFORE STARTING, NOTE THAT THERE IS A TOP AND BOTTOM TO THE LOCK ANGLE ASSEMBLY. THE BOTTOM IS IDENTIFIED BY A GROOVE CUT INTO THE SHORT PIVOT ROD.

- 1) INSERT THE TOP LONG ROD OF THE LOCK ANGLE ASSEMBLY INTO THE HOLE OF THE TOP LOCK HOUSING AND THE TOP SHORT ROD INTO THE SQUARE CUTOUT OF THE TOP LOCK HOUSING AND THROUGH THE CUTOUT IN THE BOTTOM OF THE LOCK SLIDE ASSEMBLY.

- 2) INSERT THE NYLON THRUST BEARING OVER THE BOTTOM LONG ROD OF THE LOCK ANGLE ASSEMBLY WITH THE RELEIVED PORTION TOWARD THE FLAT SIDE OF THE LOCK BAR ANGLE. INSERT THE END OF THIS PIVOT ROD INTO THE HOLE IN THE BOTTOM LOCK BRACKET.

- 3) INSTALL THE TORSION SPRING WITH THE 1 1/2 COIL END OVER THE BOTTOM SHORT ROD OF THE LOCK ANGLE ASSEMBLY AND SEAT INTO ROD GROOVES. INSERT THE FORMED END OF THE TORSION SPRING INTO THE SMALL HOLE OF THE BOTTOM LOCK BRACKET. THE LOCK ANGLE ASSEMBLY WILL HAVE TO BE RAISED TO ACCOMPLISH THIS INSERTION. MAKE SURE THE NYLON THRUST BEARING IS REPOSITIONED PROPERLY.

- 4) CHECK THE LOCK MECHANISM AT THIS TIME TO MAKE SURE THAT THE KEY WILL OPERATE AND TURN THE LOCK ANGLE ASSEMBLY INTO THE LOCKED AND UNLOCKED POSITIONS. THE KEY SHOULD TURN EASILY AND MOVE THE LOCK ANGLE ASSEMBLY FREELY. IF THE MECHANISM WORKS CORRECTLY ATTACH THE LOCK ANGLE RETAINER OVER THE UPPER LONG ROD OF THE LOCK ANGLE ASSEMBLY AND CRIMP CLOSED.

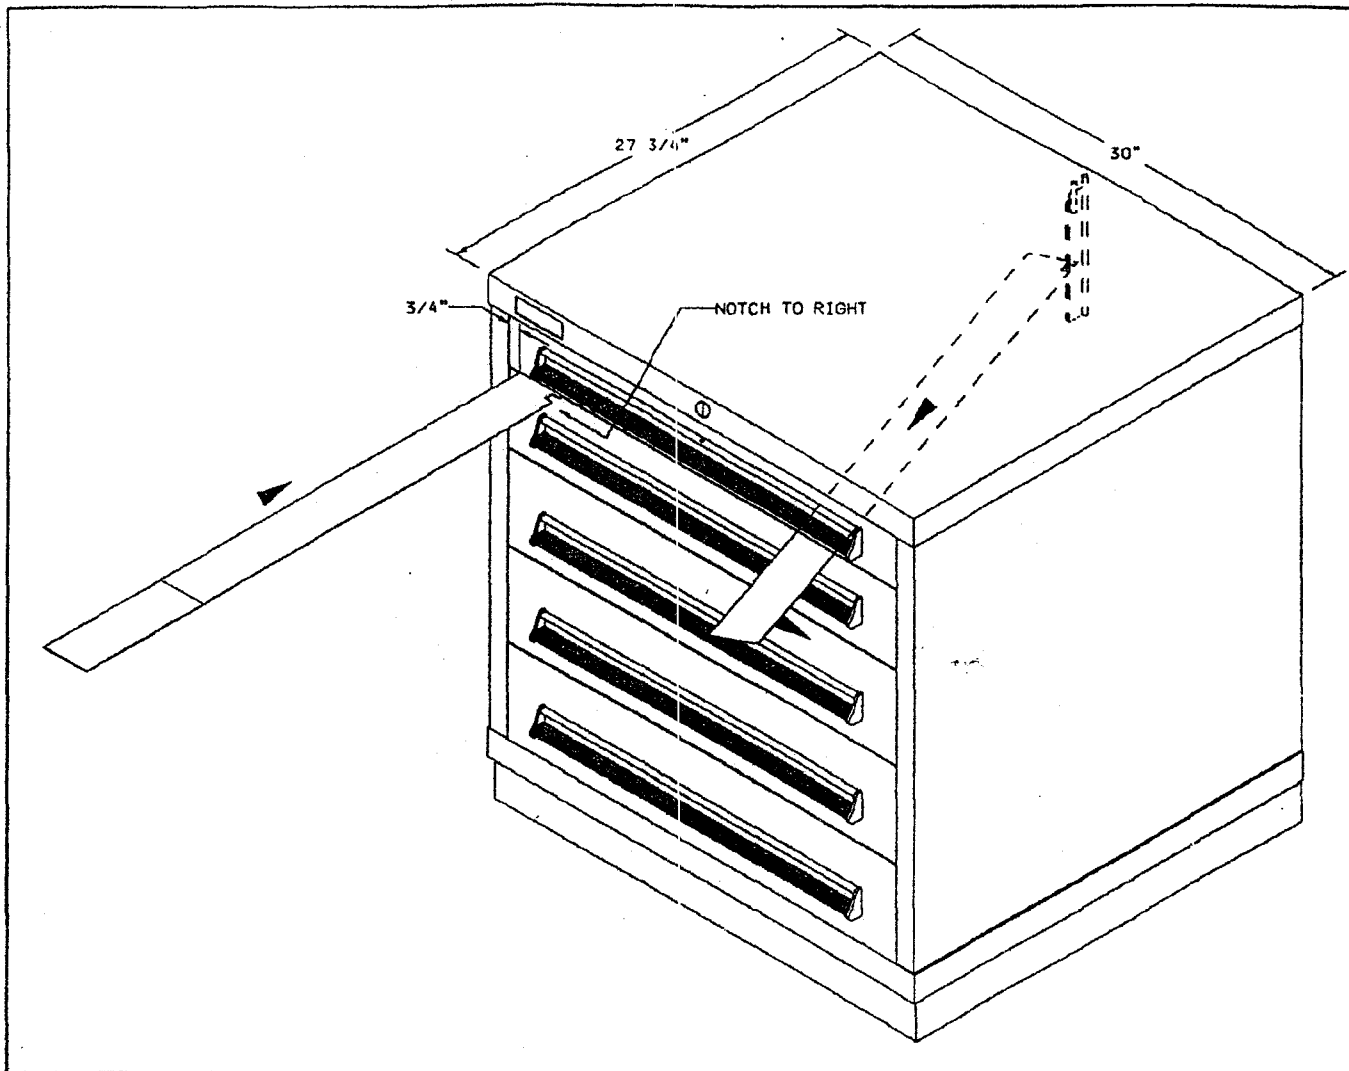
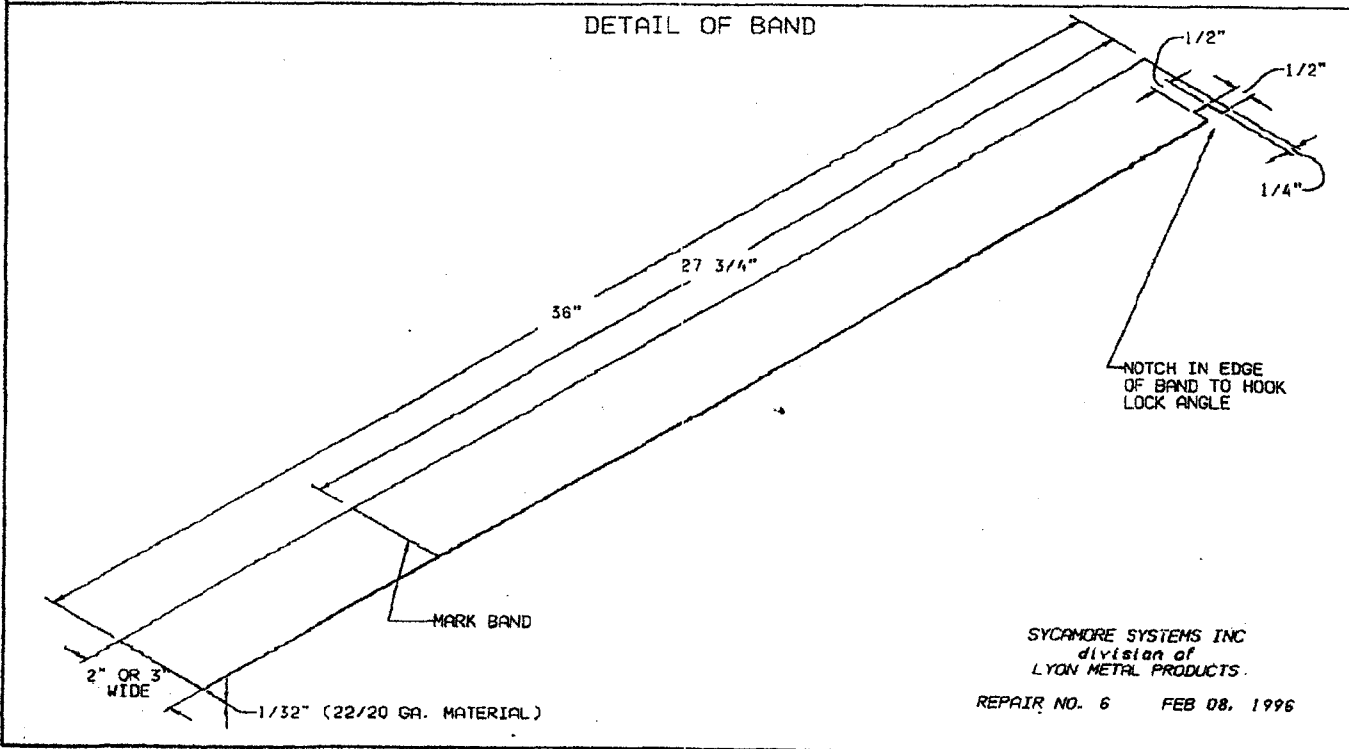
REPAIR NO. 6 FEB 08, 1996

DETAIL OF BAND
